<p>ASTINAVE EP ASTILLEROS NAVALES ECUATORIANOS</p>	INSPECCIÓN VISUAL	FOR-UAC-007
--	--------------------------	--------------------

INFORMACIÓN GENERAL											
CLIENTE	Puente del Sector Puerto Grande - Municipio de Balzar.										
FECHA INF.	5/9/2023										
INF. TEC	UAC-VT-0080-2023	N°O/T	N/A			N° DE SOLICITUD	N/A				
TIPO DE INSPECCIÓN											
DIRECTA	<input checked="" type="checkbox"/>	REMOTA	<input type="checkbox"/>	QC PINTURAS	<input type="checkbox"/>	DUREZA	<input type="checkbox"/>	BOLLARD PULL	<input type="checkbox"/>	ANÁLISIS BOBINAS	<input type="checkbox"/>
DETALLE DE LA INSPECCIÓN											
ÁREA DE INSPECCIÓN											
<ul style="list-style-type: none"> ▪ Puente de arco de tablero intermedio. 											
ELEMENTO DE INSPECCIÓN											
<ul style="list-style-type: none"> ▪ Cordones en juntas aleatorias soldadas en estructuras tubulares del puente, Estructuras Tubulares y Steel Panel. Material base: Tubo de acero de 3", 8" y 14" ▪ Material de aporte: AWS E 7018 1/8" ▪ Proceso: SMAW 											
CANTIDAD DE MUESTRAS INSPECCIONADAS Y TIEMPO DE EJECUCIÓN

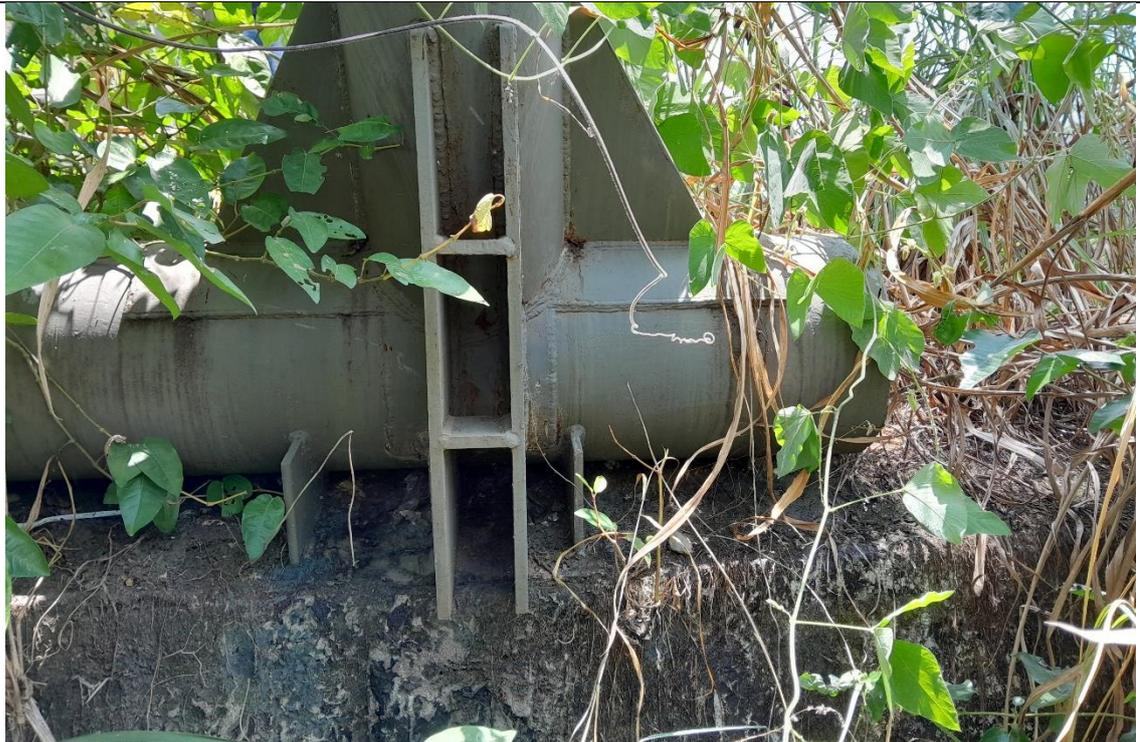
Foto 2. Típica Soldadura de filete en bases del puente, placas, rigidizadores.

IDENTIFICACIÓN DE JUNTAS	RESULTADO
TRAMO INFERIOR - BASE (Foto 2)	Satisfactorio
TRAMO TABLERO INTERMEDIO - BASE INTERMEDIO (Foto 4)	Satisfactorio
TRAMO SUPERIOR - No se tiene alcance	No hay acceso

- Una buena apariencia, tamaño y forma regular y uniforme.
- Están visualmente libres de fisuras.
- Completa fusión entre capas de soldadura y metal base.
- Juntas con penetración parcial en la soldadura de filete.
- No tienen poros y están libres de socavación.

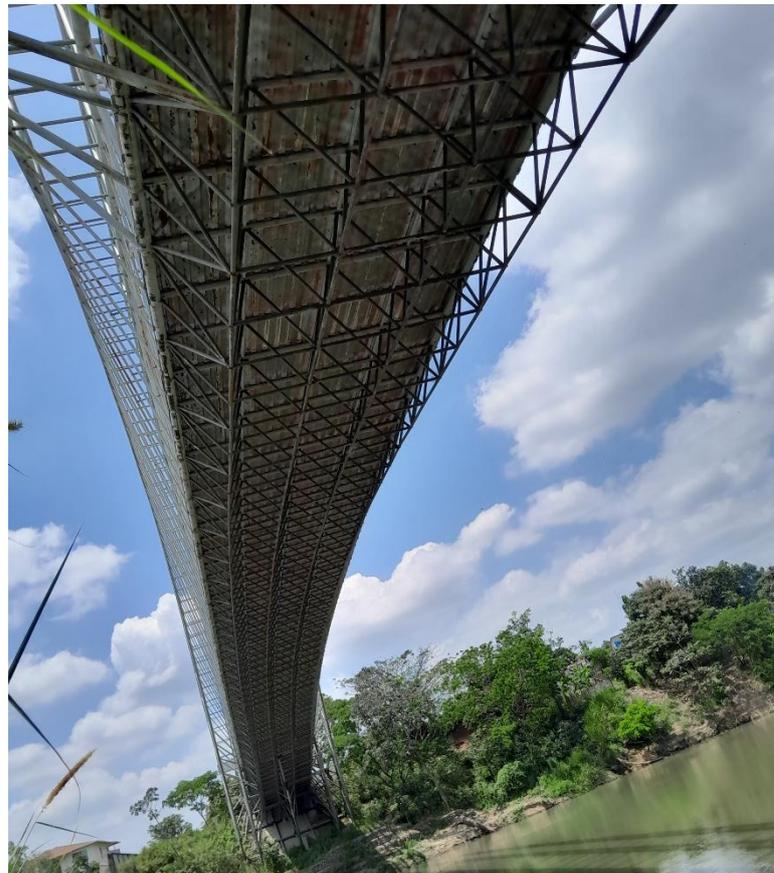
Foto 3. Elementos estructurales parte inferior.

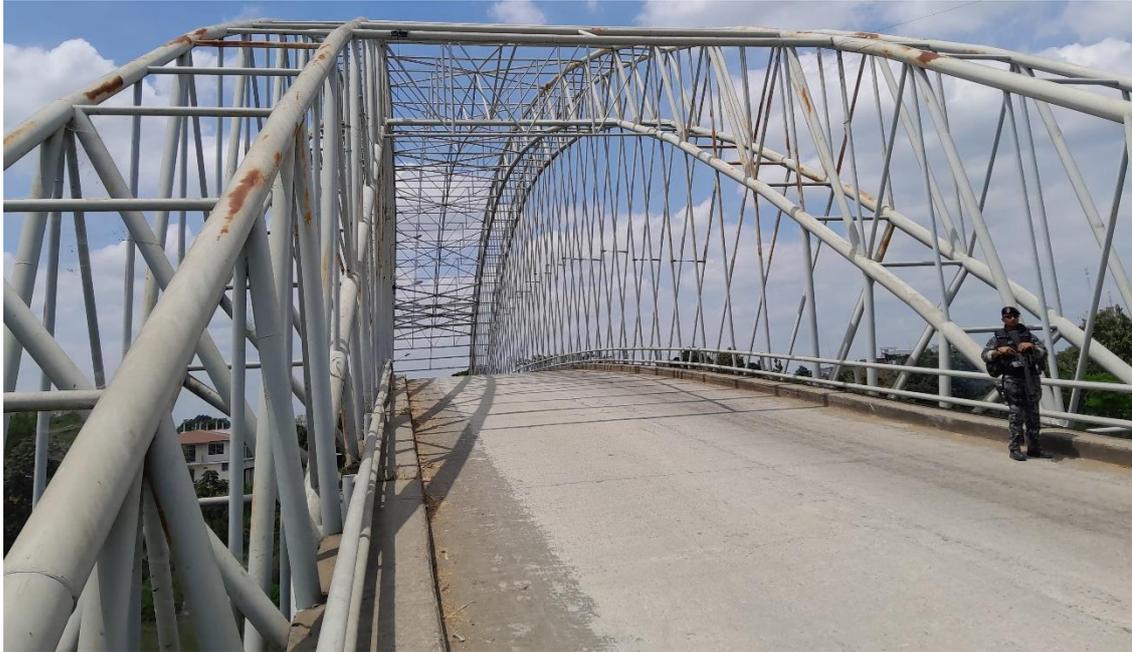
Foto 4. Elementos estructurales parte superior.

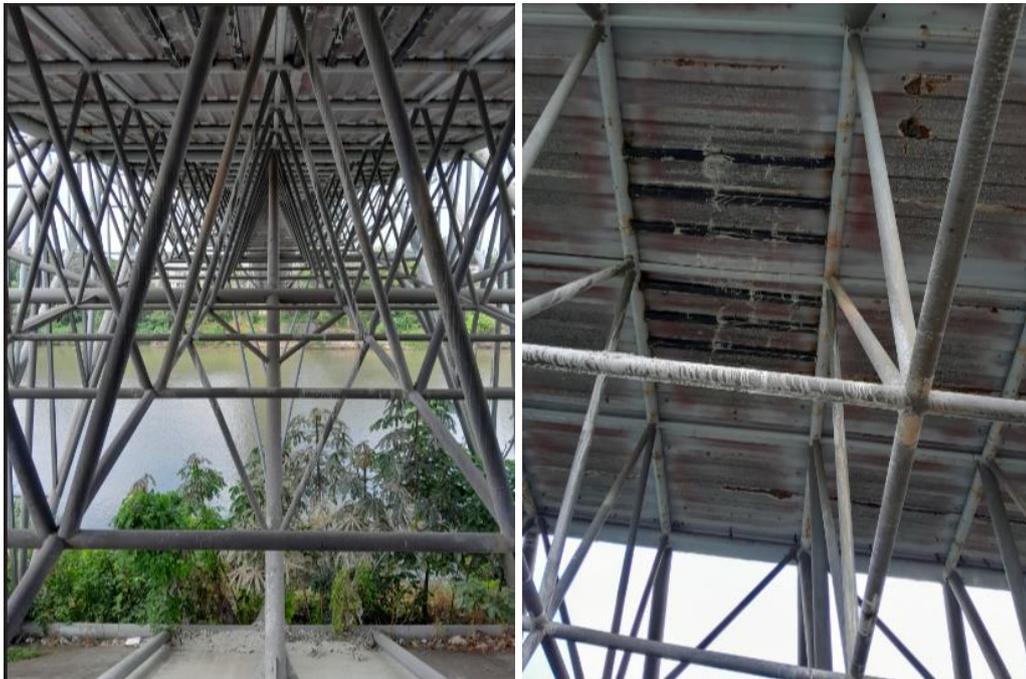
1. Al pasar un vehículo de aproximadamente 12 Ton se observó que el puente vibraba,
2. No se observó protección catódica,
3. No se tiene información como planos, memoria de cálculo, planos as built, topografía y estudios de suelo en el área de los estribos que forman parte de la cimentación del puente.
4. El Steel panel que es la base donde se soporta la capa de hormigón se encuentra en mal estado (corroído y huecos) por las filtraciones de aguas lluvias que han pasado a través del concreto y por la evaporación del agua del río, incluso se observó un tramo reparado, soportado con estructuras tubulares cuadradas (Foto 5 y 6).
5. Soldadura en buen estado.
6. Estructuras tubulares en buen estado.

Foto 5 y 6. Steel Panel en mal estado.

- Estructura tubular no presentan deformación plástica, mayor al 90 % del área de las estructuras tubulares se observa con protección de pintura,
- No se observa ningún tipo de protección catódica,
- Al pasar un vehículo de aproximadamente 12 Ton se observó que el puente vibra.
- El Steel Panel que soporta el hormigón del puente se lo observa corroído, con áreas reparadas y con huecos.

- Las uniones de soldadura en filete están libres de fisuras, libres de falta de fusión y su perfil de soldadura es satisfactoria.
- Las estructuras tubulares, se encuentran visualmente sin mayor desgaste por corrosión, con pintura, sin deformación plástica, sin protección catódica y vibra todo el conjunto puente al pasar un vehículo de aproximadamente 12 Toneladas
- El Steel Panel, la estructura base que soporta al hormigón del puente, se encuentra visualmente en mal estado ya que presenta corrosión avanzada, huecos y áreas reparadas.

- Se sugiere el cambio de la capa de Hormigón armado del puente y cambiar todos los Steel Panel en mal estados y/o cambiar el tipo de estructura base

- Steel panel por otro de mayor rigidez estructural.
- Realizar mediciones de espesores en los estructurales de acero mínimo 05 puntos por metro cuadrado de todo el puente.
